Haldex clutch

Sludge buildup and clutch debris inside a Haldex system are the main causes of precharge pump issues, usually caused by improper maintenance, overly long oil change intervals, or insufficient system cleaning when replacing the fluid.

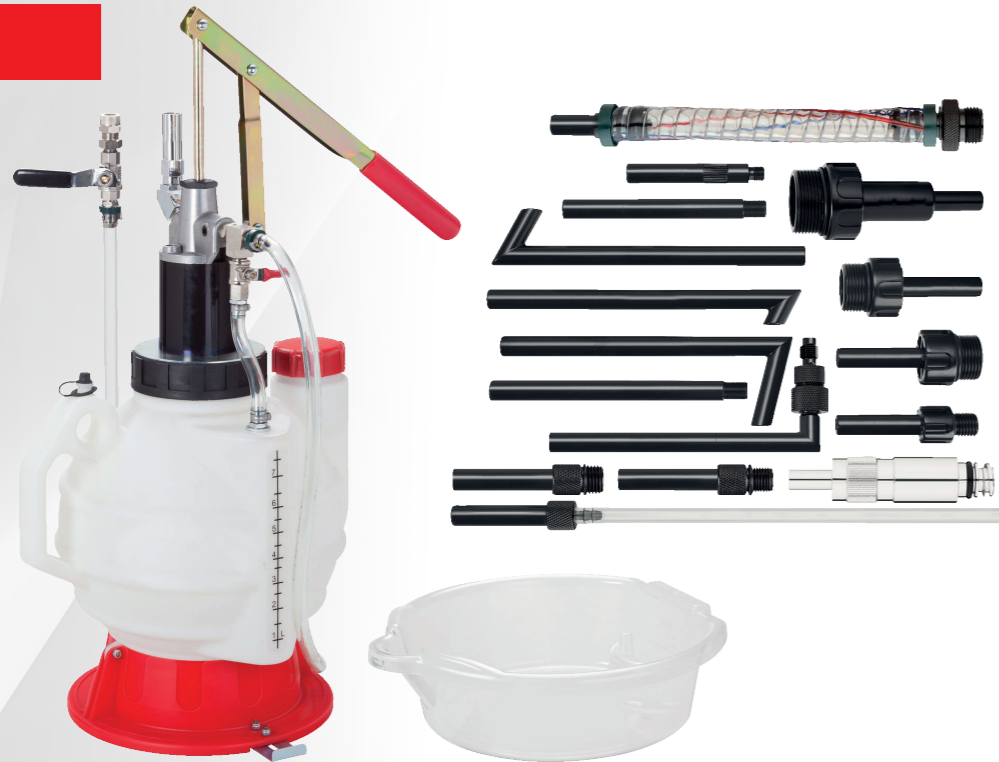
Part no. 7941

Our Hand Pump (part no. 29026) that fits our 1 l oil container or our Oil Filling Unit for Transmissions (part no. 7941) is suitable for filling the Haldex clutch.

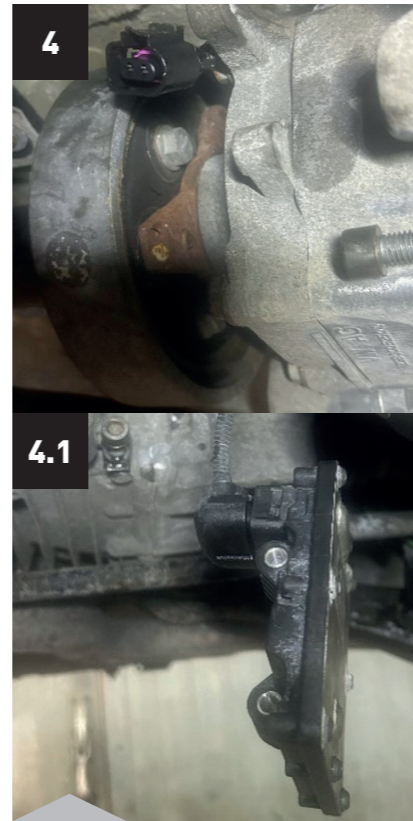
(Figures 4 + 4.1) Disconnect the precharge pump connector between the control unit and the pump. For better access, remove the control unit from its mounting.
